# MANDATORY SERVICE BULLETIN

**MSB11-4**  
 TECHNICAL PORTIONS  
 FAA APPROVED

**SUBJECT: STARTER ADAPTER INSPECTION**

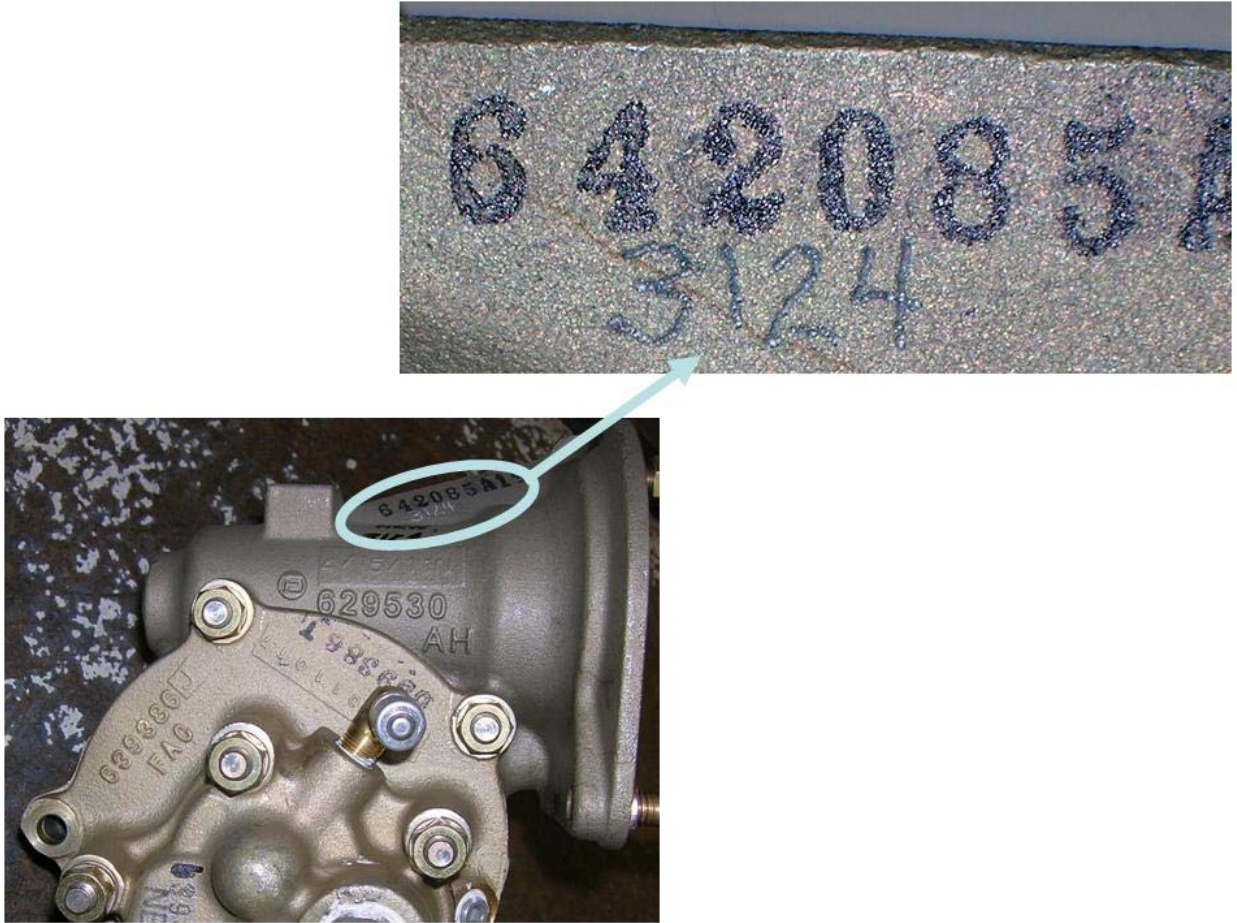
FIGURE 1 – Example of vibro-peened manufacturer code

New and rebuilt compliant starter adapters supplied by Continental Motors Inc (CMI) are identifiable by a vibro-peened manufacturer code below the ink stamped assembly part number, example of 4 digit code is shown in Figure 1.

Replacement compliant starter adapters are identified by a vibro-peened manufacturer code below the ink stamped starter adapter part number as depicted below. See Figure 1 on page 5.

Replacement starter adapters that incorporate assembly corrective action are identified by a vibro-peened manufacturer code below the ink stamped starter adapter part number as depicted below. See Figure 1 on page 5.
